Investigation of Fatigue Failure of PH 13-8 Stainless Steel

Brighter Science

- Failure of PH 13-8 Mo stainless steel rods used for main rotor assembly

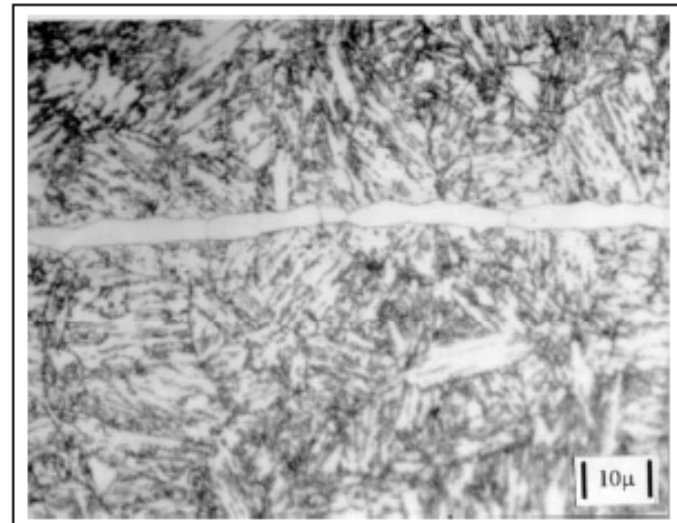
- Metallography
 - Banding C>B>A, caused by larger ingot sizes
 - C: Delta ferrite within bands and free ferrite stringers, but within spec.
 - Grain sizes much smaller than spec.

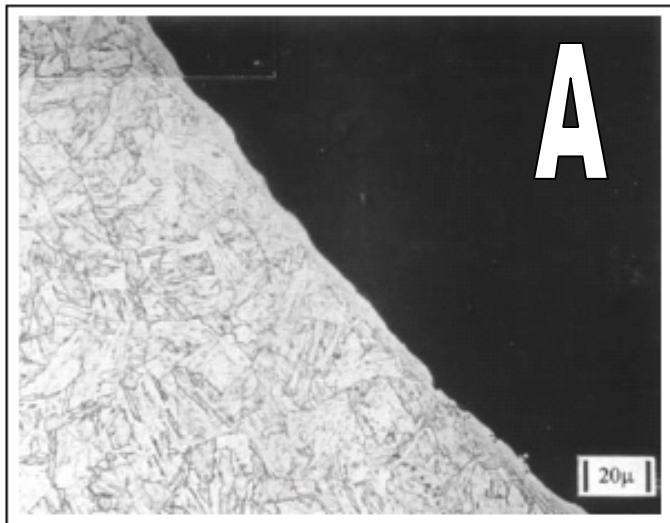
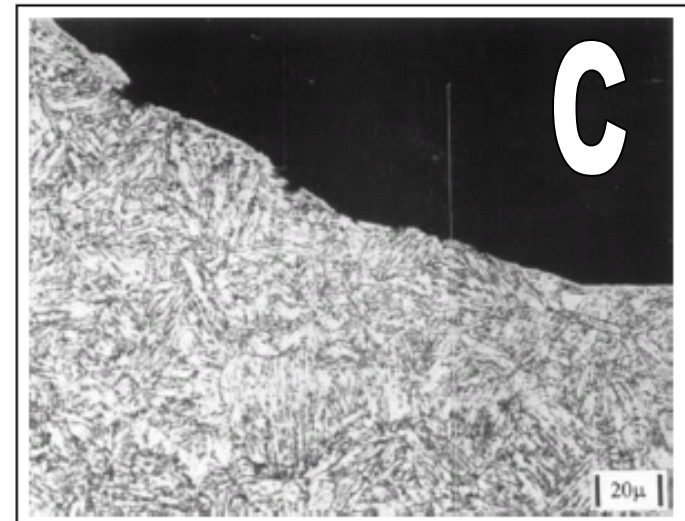
- Cold work layer
 - $A > C, B$
 - May explain differences in number of crack origins
