Investigation of Fatigue Failure of PH 13-8 Stainless Steel

Brighter Science

- Failure of PH 13-8 Mo stainless steel rods used for main rotor assembly

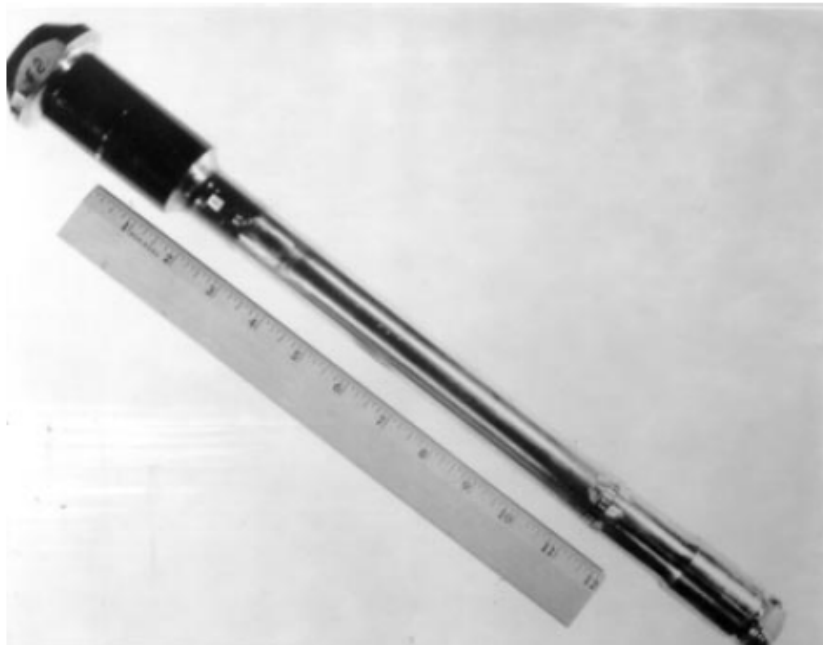
- Parts from three companies (one OEM) show different fatigue performance.
- ARL tasked to run metallurgical testing to find the reason
